D2-117017-2 REV. C

APOLLO PROGRAM

FINAL FLIGHT EVALUATION REPORT APOLLO 5 MISSION

OCTOBER, 1968

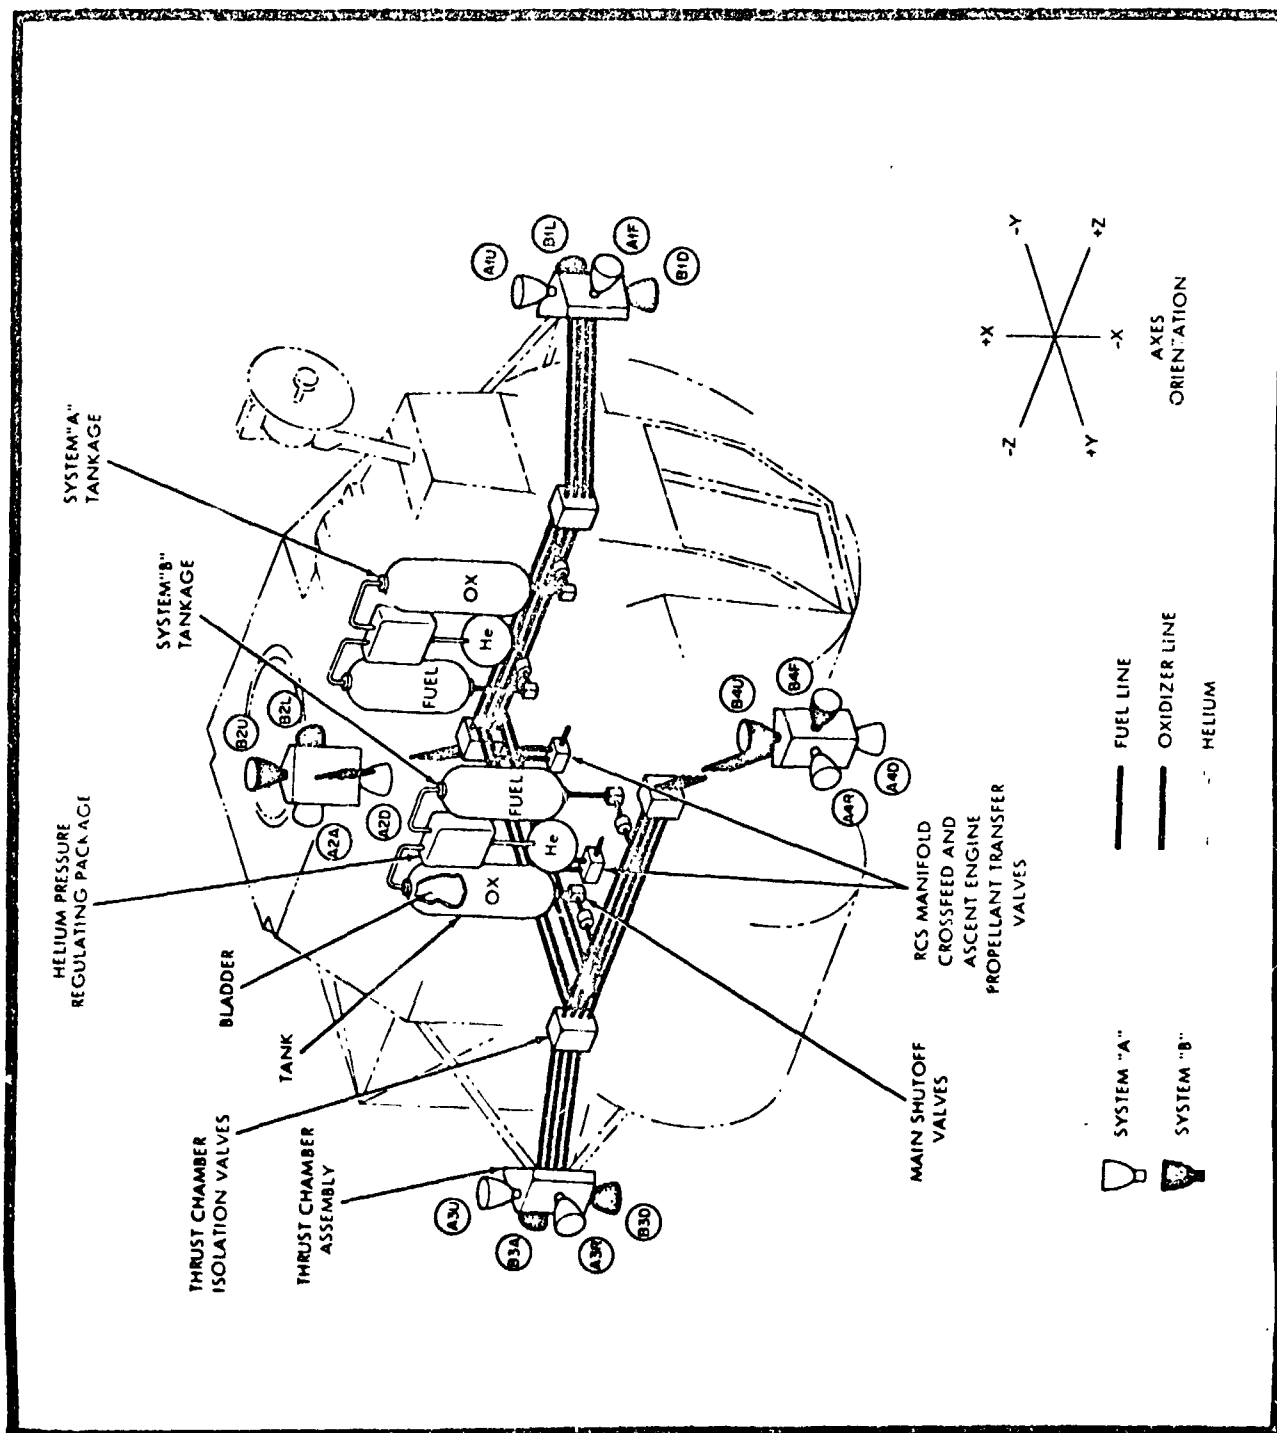
FIGURE 2.1-7 RCS INSTALLATION SCHEMATIC

No conclusion can yet be drawn; however, there is a strong indication that the valve did close, as evidenced by the rise in oxidizer and fuel engine inlet pressures. The test results will be included in MSC Anomaly Report No. 3.

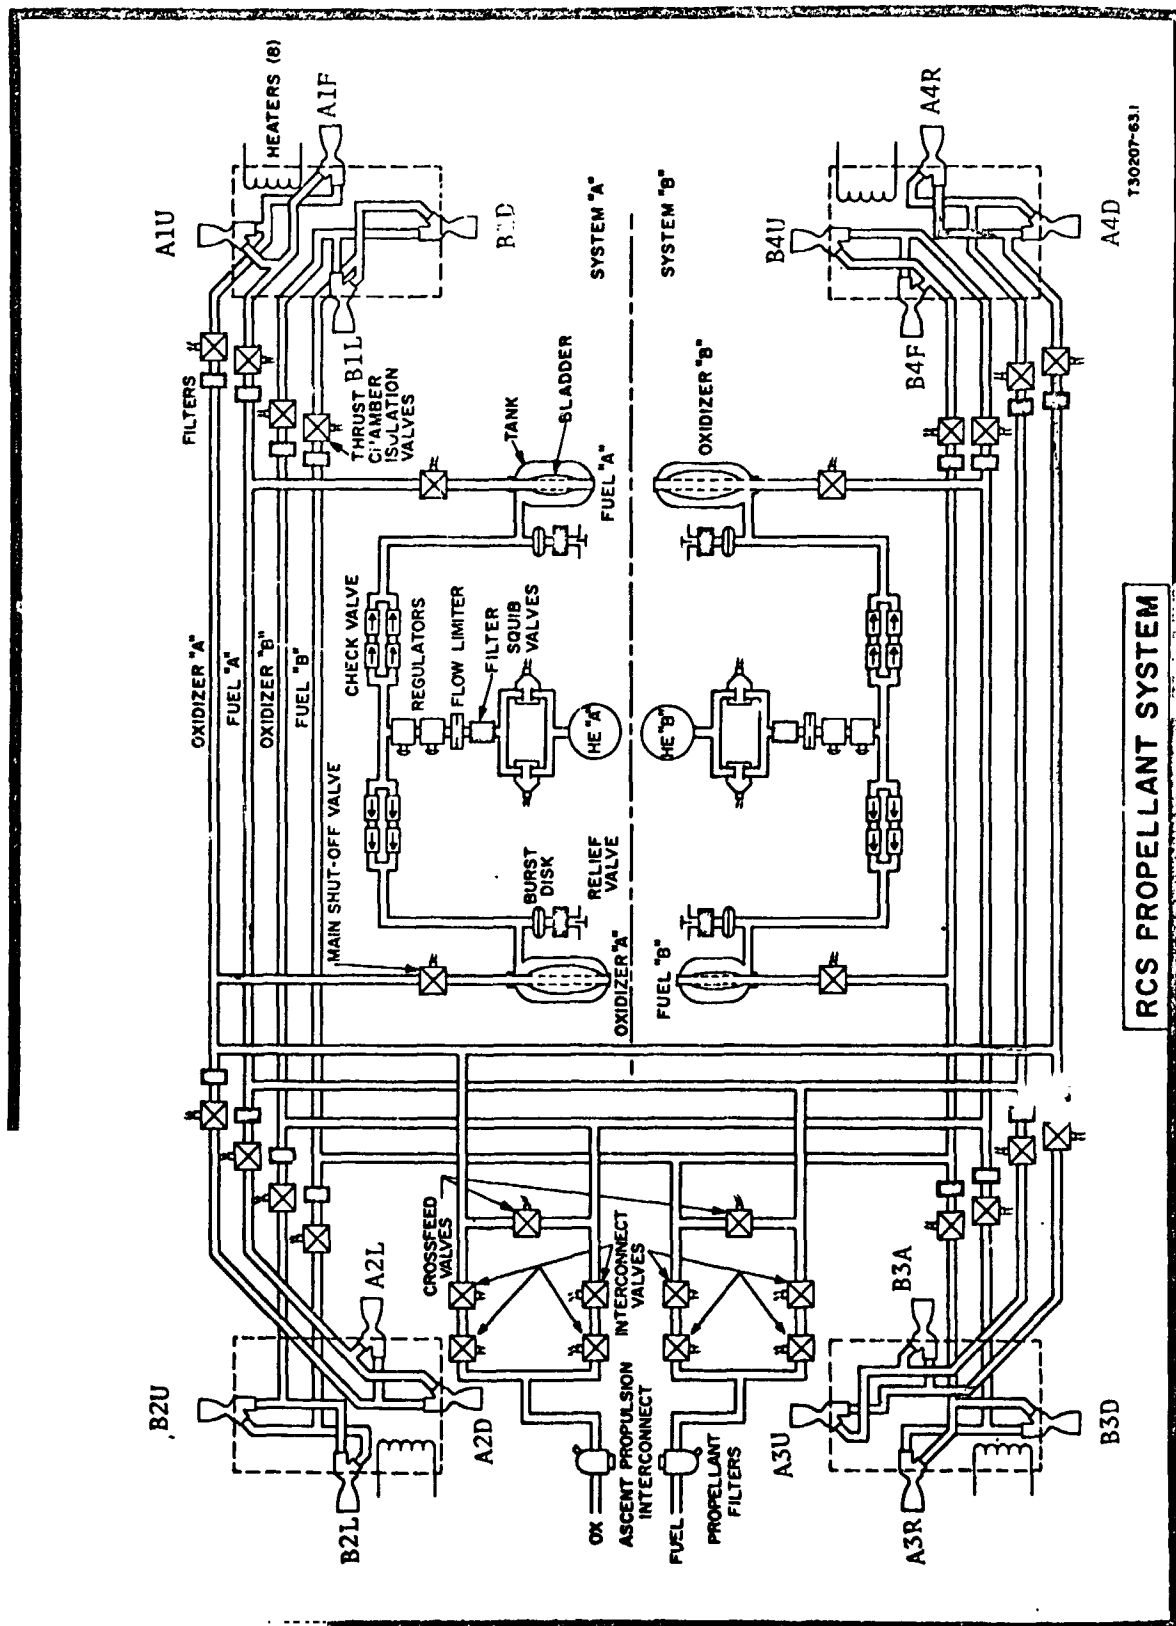
FIGURE 2.1-11

Inadvertent valve operations on LM-3 RCS will require real-time corrective action by the astronauts. The astronauts must request uplink commands, or operate the valves from the astronauts' control panel.

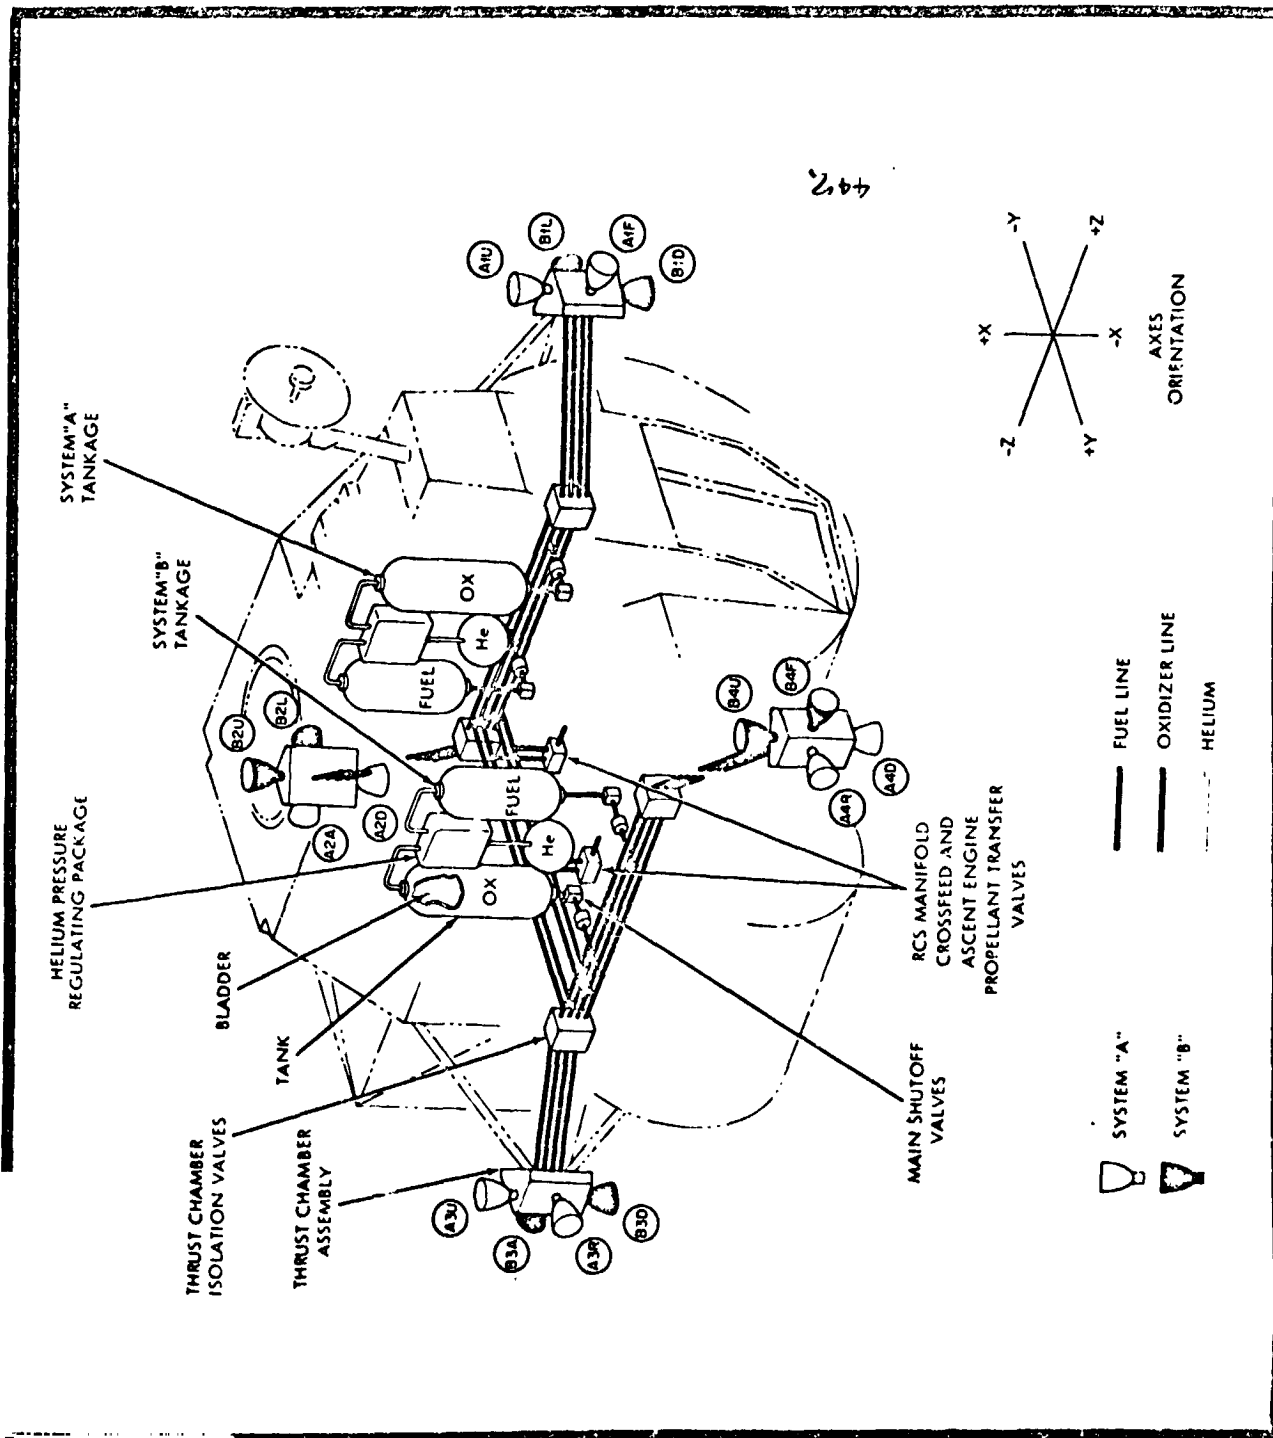
FIGURE 2.1-12 RCS INSTALLATION

The LM-3 RCS thruster duty cycle requirements will be significantly less than those experienced on the LM-1 RCS thrusters during Apollo 5 mission. Therefore, RCS thrusters for the LM-3 are considered adequate for the planned AS-504 mission.

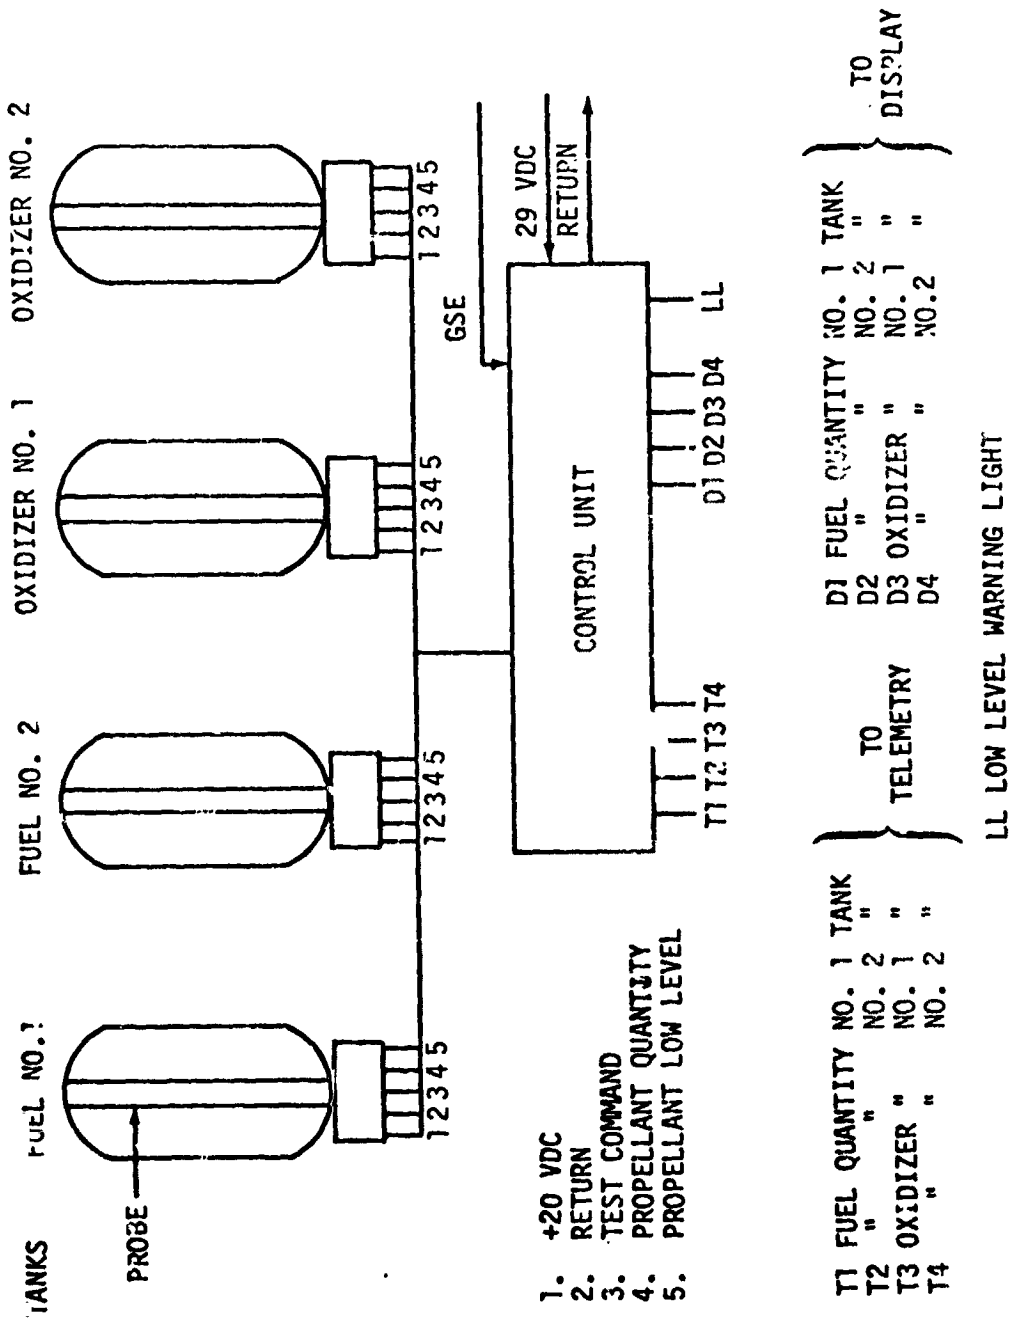
FIGURE 2.1-13

NO. 2.1.13	TITLE: FAILURE OF PROPELLANT QUANTITY GAUGING SUBSYSTEM, NO. 2 TANKS
SYSTEM: LM	MISSION: APOLLO 5
SUBSYSTEM: DPS	EVENT TIME: PRE-LAUNCH
DESCRIPTION: ERRONEOUS PROPELLANT QUANTITY INDICATIONS FROM NO. 2 FUEL AND OXIDIZER TANKS PRIOR TO AND DURING FLIGHT.	
IMPACT: NONE ON APOLLO 5. NEW GAUGING SYSTEM CONTROL UNIT WILL BE USED ON SUBSEQUENT VEHICLES.	
STATUS: AN MSC FAILURE INVESTIGATION HAS ATTRIBUTED THE FAILURE TO A FAULTY TRANSISTOR WITHIN THE GAUGING SYSTFM. THE GAUGING SYSTEM CONTROL UNIT HAS BEEN RE-CONFIGURED FOR SUBSEQUENT VEHICLES TO UTILIZE HIGH-RELIABILITY PARTS. QUALIFICATION TESTING OF THE NEW CONFIGURATION IS COMPLETE. (SEE ATTACHED FIGURE 2.1-13.)	
ACTION: NO FURTHER ACTION REQUIRED.	
ORGANIZATION: 5-2464	RESOLUTION: CLOSED
REFERENCES: MSC 10-DAY REPORT, PAGE 11; MSC 60-DAY REPORT, PAGE 6.12-4, ITEM 6.12.6. LED 25-23, LM-3 DCR REPORT	DATE: 10/4/68 REV: C

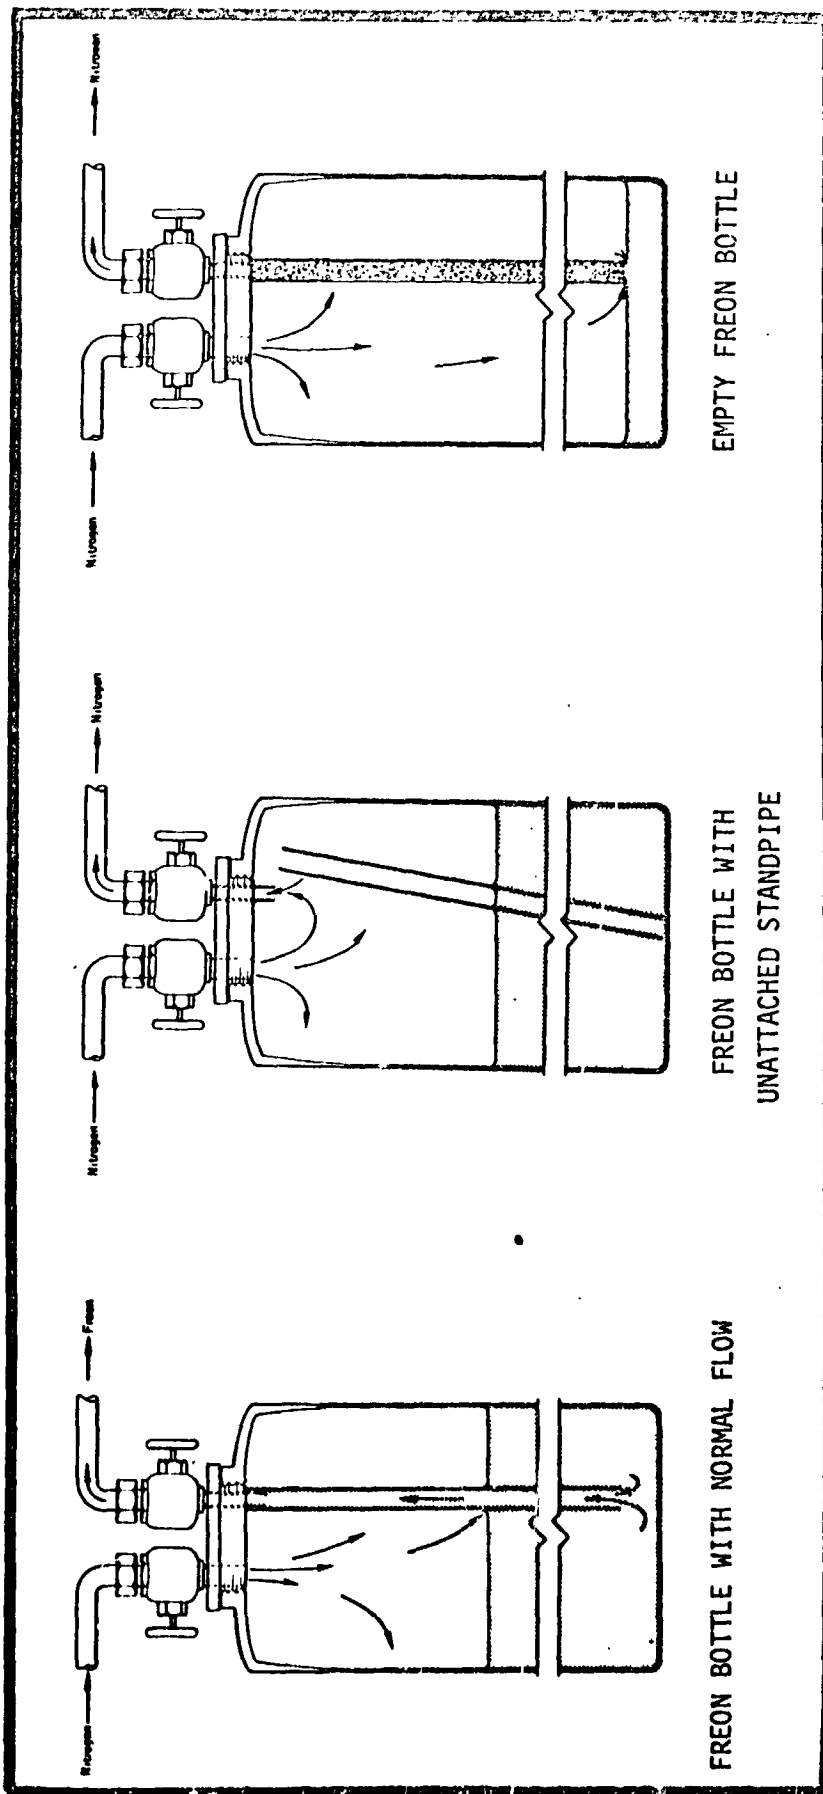
FREON BOTTLE STANDPIPE ARRANGEMENT
FIGURE 2.3-2

The water/glycol coolant of the Lunar Module (LM) heat transport system was cooled prior to launch by two freon boilers in the Environmental Control System. Freon was supplied to the boilers from two ground support equipment freon bottle racks (Fig. 2.3-1). The freon was expelled from the bottles by nitrogen pressure that forced freon through the standpipe and into the manifold (Fig. 2.3-2). Rack 1 was mounted on a weight scale to determine the amount of freon in the bottles. Freon flow was initially set at 50 LB/HR.
